NPIC/R-155/63

July 1963

PHOTOGRAPHIC INTERPRETATION REPORT

# PROBABLE DESTROYERS AT VLADIVOSTOK, USSR

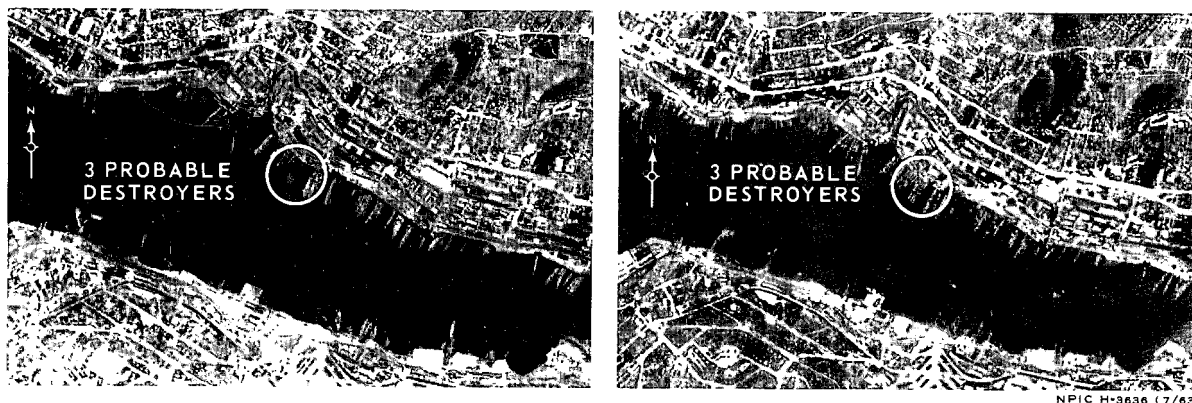
using KEYHOLE photography from both Missions [REDACTED] (Figure 2). On Mission [REDACTED] only nominal detail is discernible on the topsides of the vessels. On Mission [REDACTED] however, considerable topside clutter is visible and a more detailed analysis is feasible. A provisional profile sketch is shown in Figure 3.

FIGURE 2. COMPARATIVE PHOTOGRAPHY OF PROBABLE DESTROYERS AT VLADIVOSTOK: MISSION [REDACTED] (LEFT) AND [REDACTED] 25X1D

less than optimum. On Mission [REDACTED] the aft camera is sharper but more detail is recorded on the forward camera whose imagery is "washed out".

In spite of the photographic limitations stated above, it is concluded that three vessels are involved and that the vessels are probably destroyers.

(1) The three vessels appear to be similar if not identical, so that conclusions derived from one are applicable to all three.

(2) Their decks are perceptibly higher than the shore.

(3) The two outermost vessels appear to have sharp bows.

(4) All three appear to have a blunt stern, with water visible between the stern and the shore; the stern of a submarine would fade away in a curve without a sharp break.

(5) The topsides of the vessels have multiple rises, one of which on each vessel rises to a point as would a tripod mast.

(6) Possible gun turrets are visible near the bow and the stern.

(7) The sides of the vessels are parallel midships rather than curved.
